Pick the right surface and avoid any slip-up – for ever

Fifteen years ago Permaban discovered that the slip resistance of floors hardened with alloy-based dry-shake floor hardener is better after several years in use than a new floor surface. Although perhaps counter-intuitive, it is actually the case that various aspects of good-quality new power-floated concrete floors improve with age and usage. These include the appearance of the floor and could include its slip resistance properties provided the surface incorporates the appropriate fine aggregate. **Andrew Mackenzie** of Permaban reports.

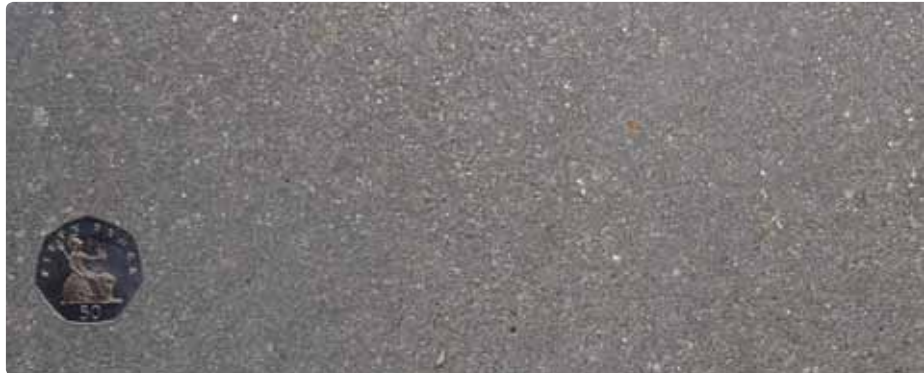
Figure 1 top: Surface texture of a lobby area in B&Q after the Permashake Alloy Light Grey surface was chemically aged by acid etching.

Figure 1 shows a close-up of the surface of a light grey Permashake Alloy floor in a B&Q lobby area. This floor was chemically aged for Permaban by Texturcare of North Walsham; 150 B&Q new store lobbies have now been treated this way. The main store areas are constructed using Permashake Quartz Light Grey, while the alloy grade is used in the lobby areas. Both areas are power-floated smooth. Chemical ageing is carried out only in the lobby areas. The reason for this is that the lobby areas can often become wet. This has been the standard treatment for these lobbies since 1999, when B&Q found that the traditional mats/wells previously used were actually proving to be a trip hazard and it sought a better solution.

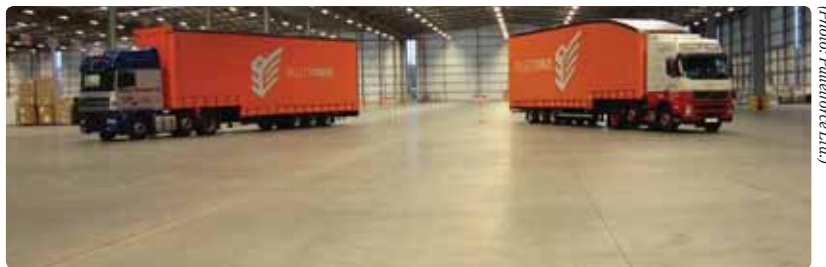
Photo: Palforce Ltd

Figure 2 above: Showing a warehouse with the shot-blasted Permashake Alloy Natural floor in operation.
