Southgate Industrial Park, Moscow

Rodney Arnold, Permaban, Ivybridge, UK

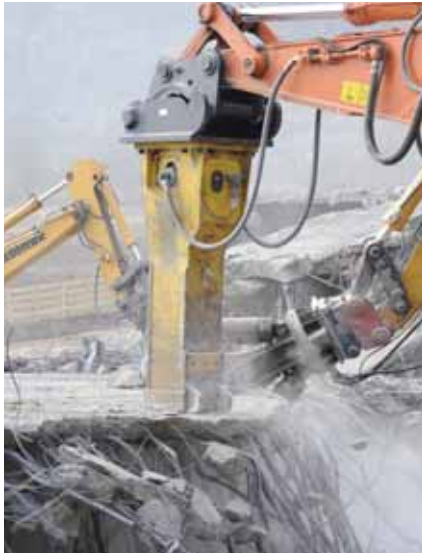
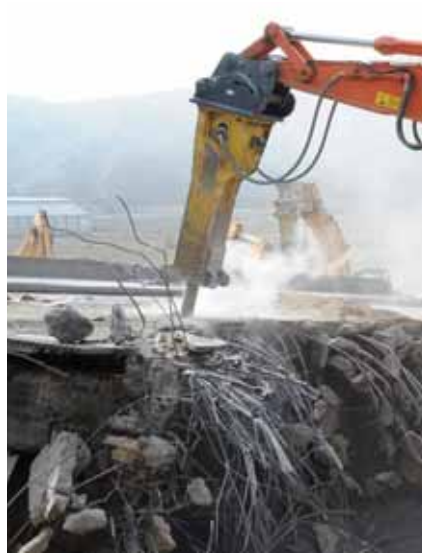
Figures 5 and 6: Secondary breaking of material. Hydraulic cutters and pulverisers break concrete and reinforcement bar in one step.

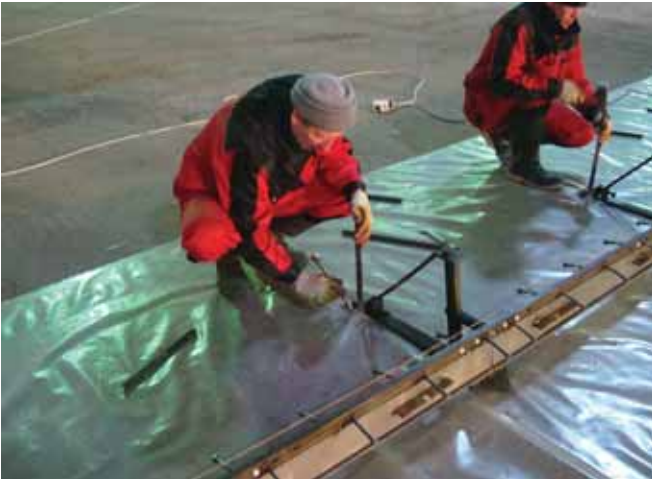
Figure 1: Installation of AlphaJoint GD8 at Southgate Industrial Park, near Moscow, Russia.

The Permaban/Romex team decided that by using large-area casting techniques, the Somero SXP Laser Screed and Somero Topping Spreader they would try to achieve FM1 on bay sizes of 24m wide between columns and 48m long. Each pour was contained inside AlphaJoint leave-in-place formwork system fixed using AlphaFix, which Romex first used on its first concrete floor project back in 2004.

One of the features of using the AlphaJoint with the AlphaFix is that the bay closing formwork does not need to be placed until the laser screed is on its penultimate pour for the bay. The speed that the AlphaJoint can be installed and micro-adjusted for line and level permits the installation to follow behind the laser screed. This allows the concrete truck to back down directly to the position of placement without having to turn on the reinforcement and slip membrane thus preventing rucking of the membrane and rutting of the sub-base.

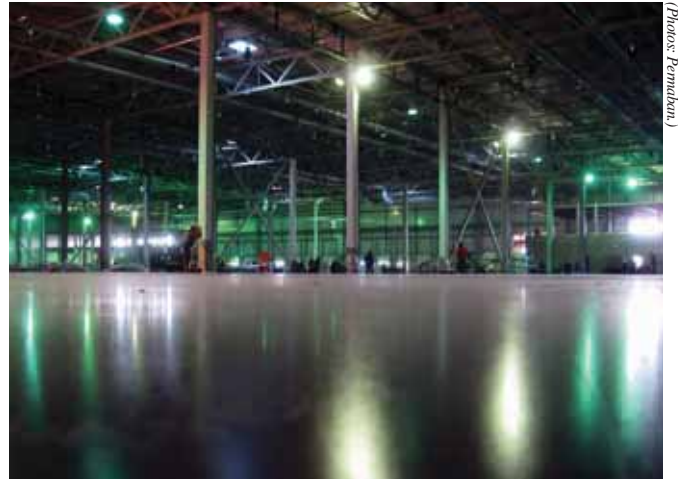
Figure 2: The completed first floor area at Southgate Industrial Park.

site, which resulted in the first day's pour taking some 15 hours. However, it was very pleasing to inspect the first day's measurement readings, which demonstrated that Category FM1 Properties II and IV had been achieved with only 2% of the measurement falling outside the 95% requirement, thus delivering an excellent floor to the client that more than achieved his requirement to provide a high durability floor with a professional floor appearance.

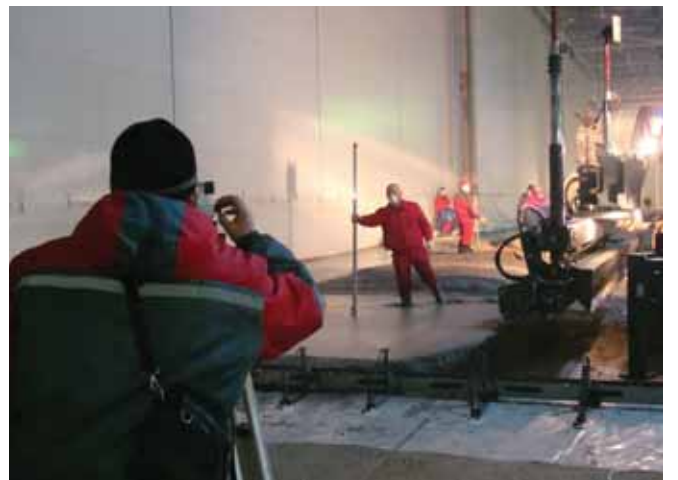
Figure 4: Check and recheck of the floor levels.

As the concrete was being placed, consistent level checks were taken of the levelled concrete and the formwork at the edges. The surface was skip floated and straight edged following the levelling by the laser screed. Prior to and during the power floating and the power trowelling operations, further straight edging and level checking was carried out constantly, both within the general floor area and across the joints to ensure achievement of both Property II along the joints and Property IV in the general floor area.

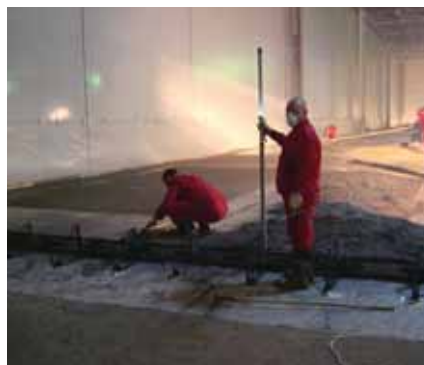
Figure 5: Checking the level of the AlphaJoint.

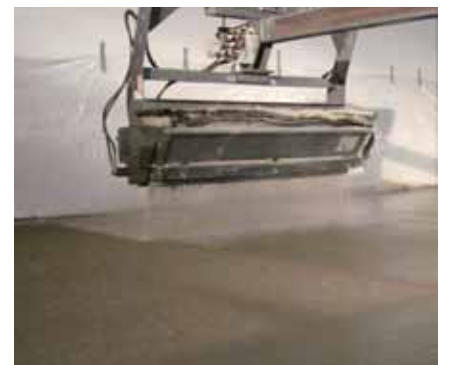
Figure 6: Application of DryShake Floor Hardener.

AlphaJoint formwork system complete with joint intersections, 305 tonnes of FibreTop Natural Grey Floor Hardener and 6200 litres of Permaseal cure/seal product for the first area of 65,000m².
